## **Abrasive Three-Body Wear of Polyethylene Caused by Broken Multifilament Cables of a Total Hip Prosthesis A Report of Three Cases**

THOMAS W. BAUER, JIANG MING, JAMES A. D'ANTONIO and LAWRENCE G. MORAWA  
*J Bone Joint Surg Am.* 1996;78:1244-7.

# Abrasive Three-Body Wear of Polyethylene Caused by Broken Multifilament Cables of a Total Hip Prosthesis

A REPORT OF THREE CASES\*

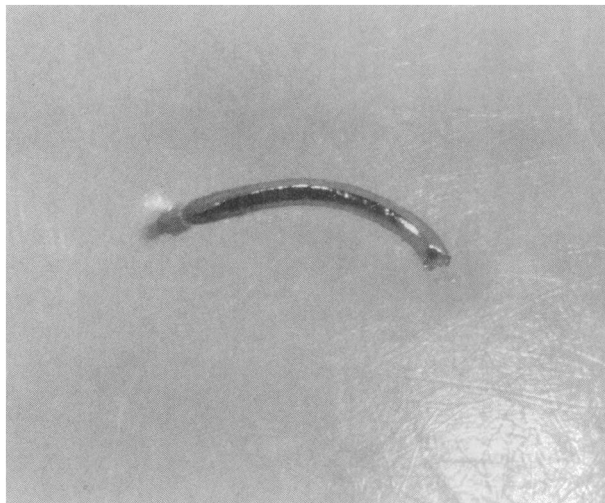
FIG. 1-C

Photograph, made with a dissecting microscope, showing a filament of wire embedded in the polyethylene of the acetabular component. Scratches of the adjacent polyethylene are also evident ( $\times 30$ ).

The retrieved polyethylene liner of the acetabular component contained obvious fragments of metal wire embedded in the weight-bearing portion of the articular surface. Five metal fragments that had a diameter of 320 micrometers and ranged from 1.2 to 3.7 centimeters in length were found (Fig. 1-C). Abrasive wear, consisting of numerous fine scratches, was also present in the weight-bearing region of the polyethylene adjacent to the embedded metal. Energy-dispersive x-ray spectroscopy, which was used to identify the composition of the metal debris, showed that the embedded filaments and the separately submitted cables were composed of identical cobalt-chromium alloy

Although multifilament cables may have theoretical advantages over monofilament wires, accelerated three-body wear is a concern. In the hips available for our analysis, the mechanism by which the cables broke appeared to be fretting at their junction with the grip assembly. Fraying of the cables with breakage of individual wire filaments at this site was evident in one of the retrieved specimens and could also be visualized on several of the radiographs. Our results show that broken filaments can migrate into the joint space, become trapped between the articulating surfaces of the femoral and acetabular components, and participate in abrasive third-body wear. Besides directly scratching the articular surface of the polyethylene, the filaments can become embedded in the polyethylene and scratch the surface of the femoral head with each step that the
